Case study  
Mercure Hotel, Brighton  
rear archway  
refurbishment

The grade 2 listed Mercure Brighton Hotel was built in 1864 and is a landmark building situated on Brighton's busy seafront.

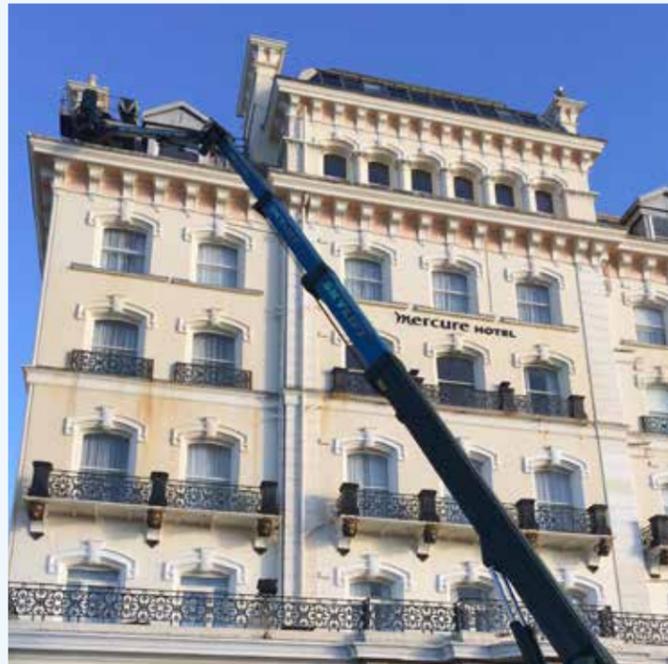
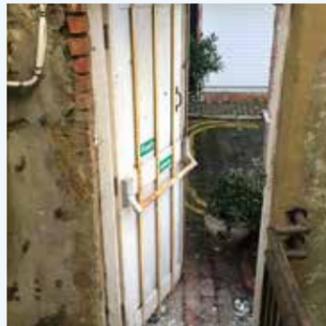
Right and below right: The repairs were extensive, but the results were worth all the effort!

We repaired all cracks/spalls using a proprietary cement-based external grade render repair system. We patch-painted a small area to match the existing finish. Once approved by the conservation officer, we applied one mist and two full coats of water based, high performance matt finish masonry coating that carries BBA certification.

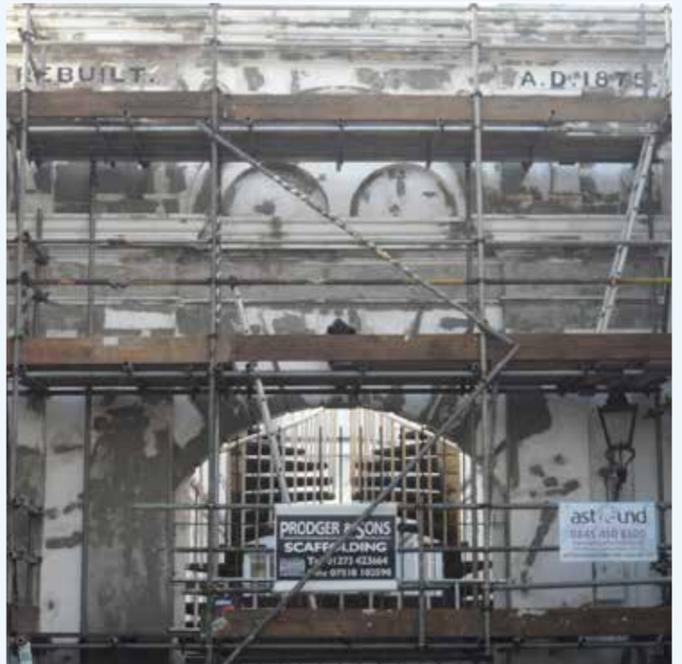
Above: Our masonry refurbishment team were required to undertake delicate repairs in difficult to access areas.

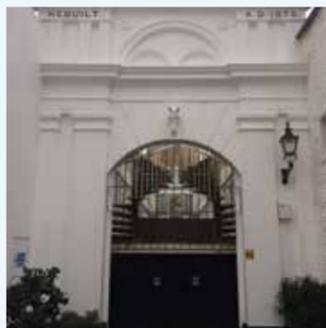
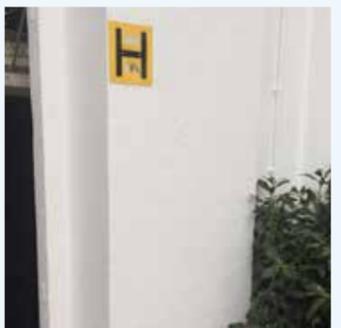
Left: Escape routes were kept operational throughout the scheduled works.
