Case study  
Mercure Hotel, Brighton  
rear archway  
refurbishment

The grade 2 listed Mercure Brighton Hotel was built in 1864 and is a landmark building situated on Brighton's busy seafront.

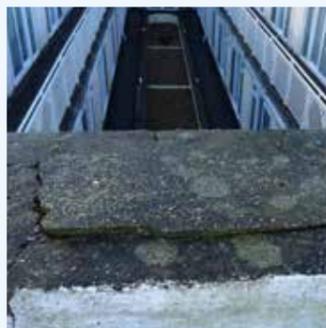
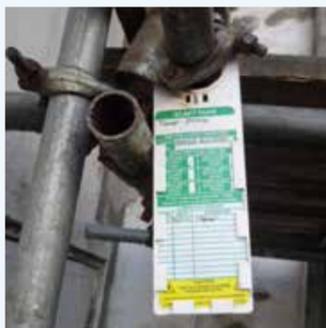
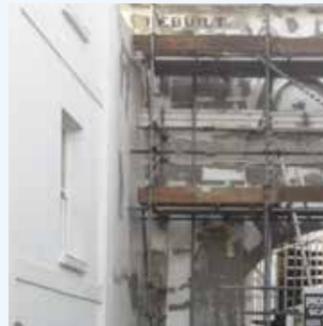
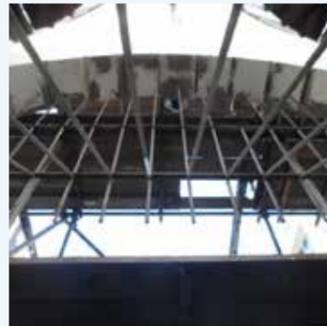
Bottom: Some of the stonework required substantial repairs involving the removal and replacement of large chunks of masonry.

Above: Our masonry refurbishment team were required to undertake delicate repairs in difficult to access areas.

We repaired all cracks/spalls using a proprietary cement-based external grade render repair system. We patch-painted a small area to match the existing finish. Once approved by the conservation officer, we applied one mist and two full coats of water based, high performance matt finish masonry coating that carries BBA certification.
